DYNAMIC
RIVERS

**North Brook Weir
Restoration Design
FINAL Report**

Warwickshire Wildlife Trust

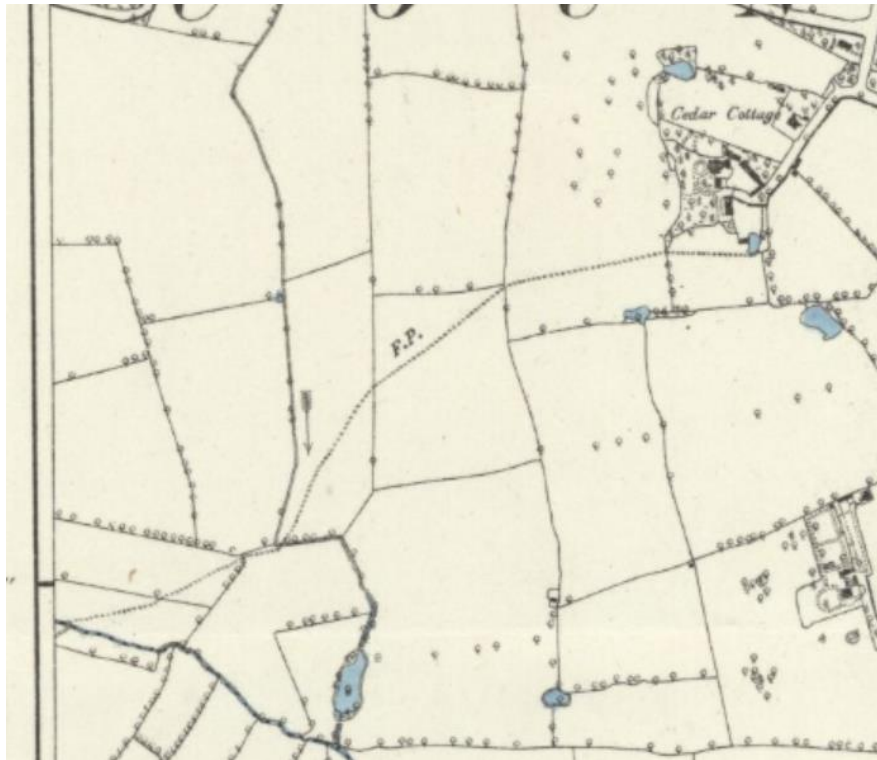
Figure 2.1 Historically more sinuous middle reach of the Erewash, 1888 Map.

Straightening predates the earliest available OS Maps (1888 – See Figure 2.1) but aerial imagery (Figure 1.1) and the fluvial audit suggests there may have once been a pond in the northern section of the site that currently exists as a partly functional wetland.

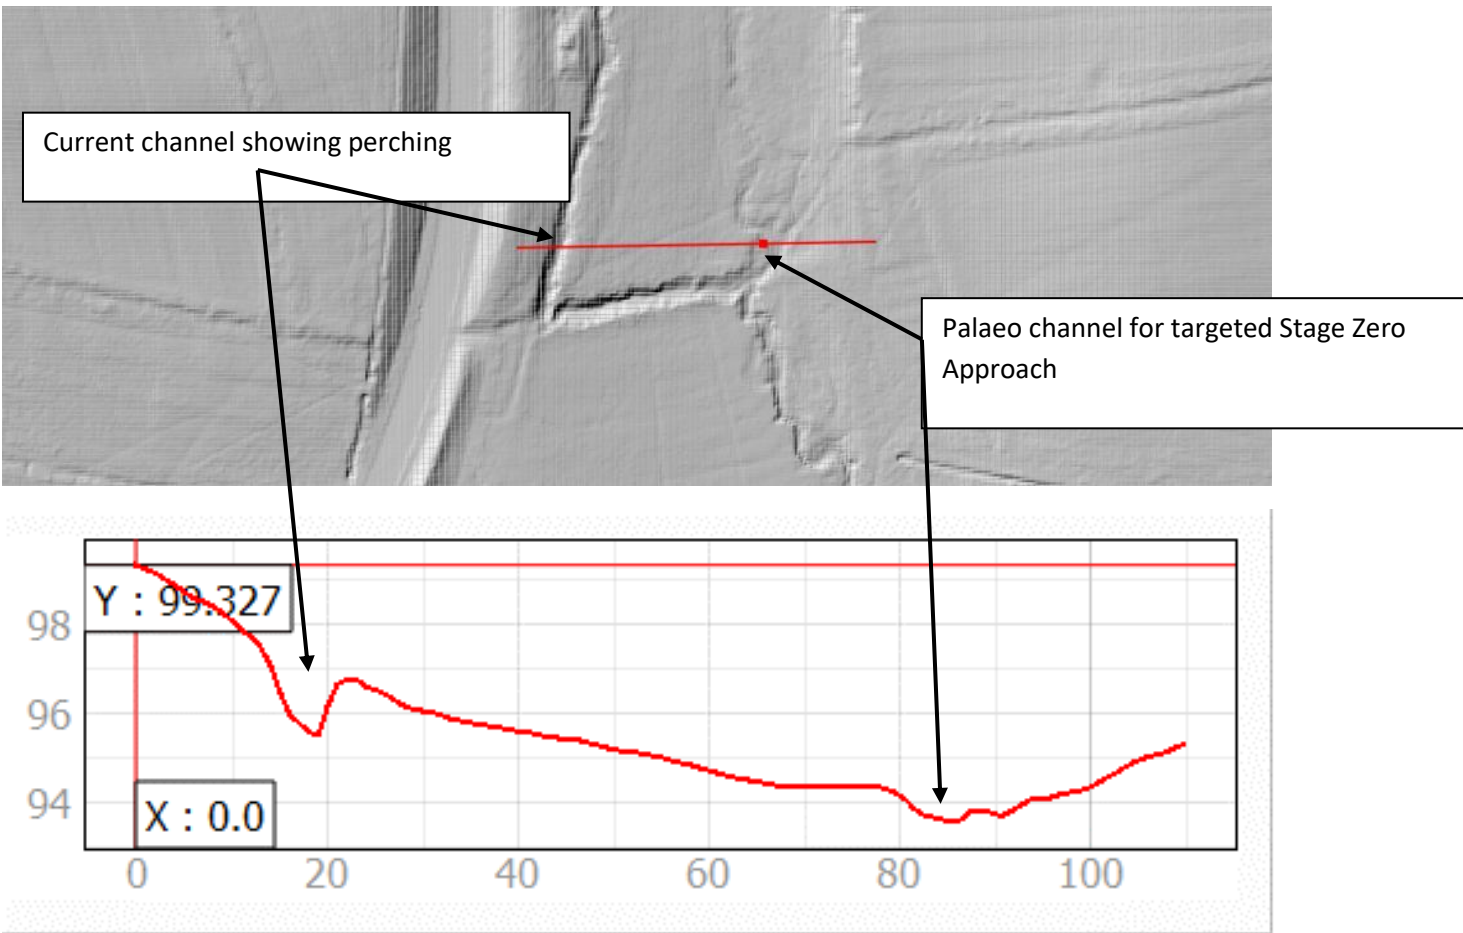
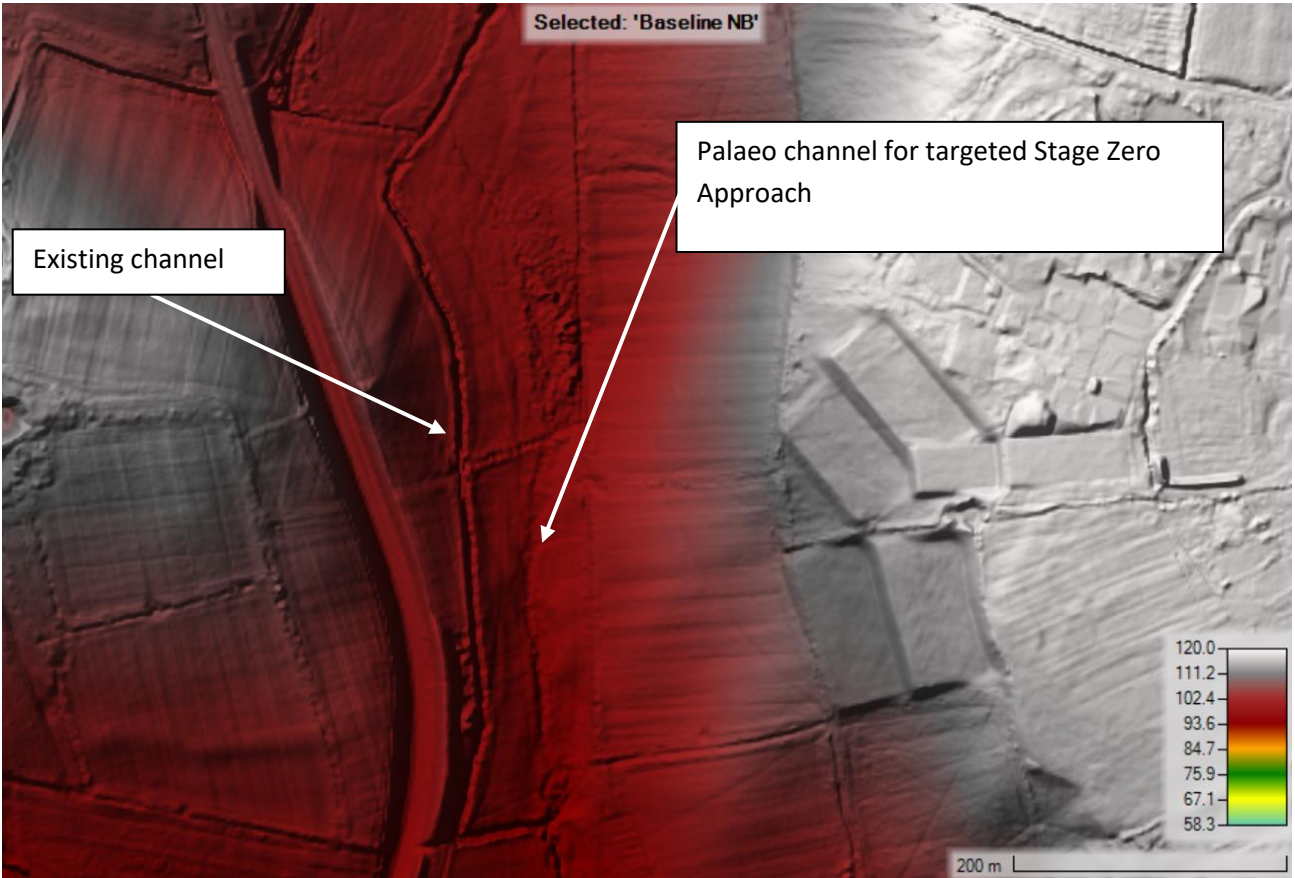
Figure 2.2 LIDAR and profile across study reach showing potential high-level opportunities and palaeo channel across the floodplain

The North Brook has been subject to significant historic modification, through channel straightening and through the inclusion of infrastructure within the channel, including weirs and culverts. It appears that some weirs have been removed over time or failed, and this offers insight into how the watercourse may react to weir bypassing. North Brook has been completely realigned to one side of the valley bottom, leaving it perched in the floodplain compared to where it once naturally flowed, this palaeo channel (evident in the LIDAR – Figure 2.2) is to be targeted for a potential 'stage zero' approach to bypass this particular weir.

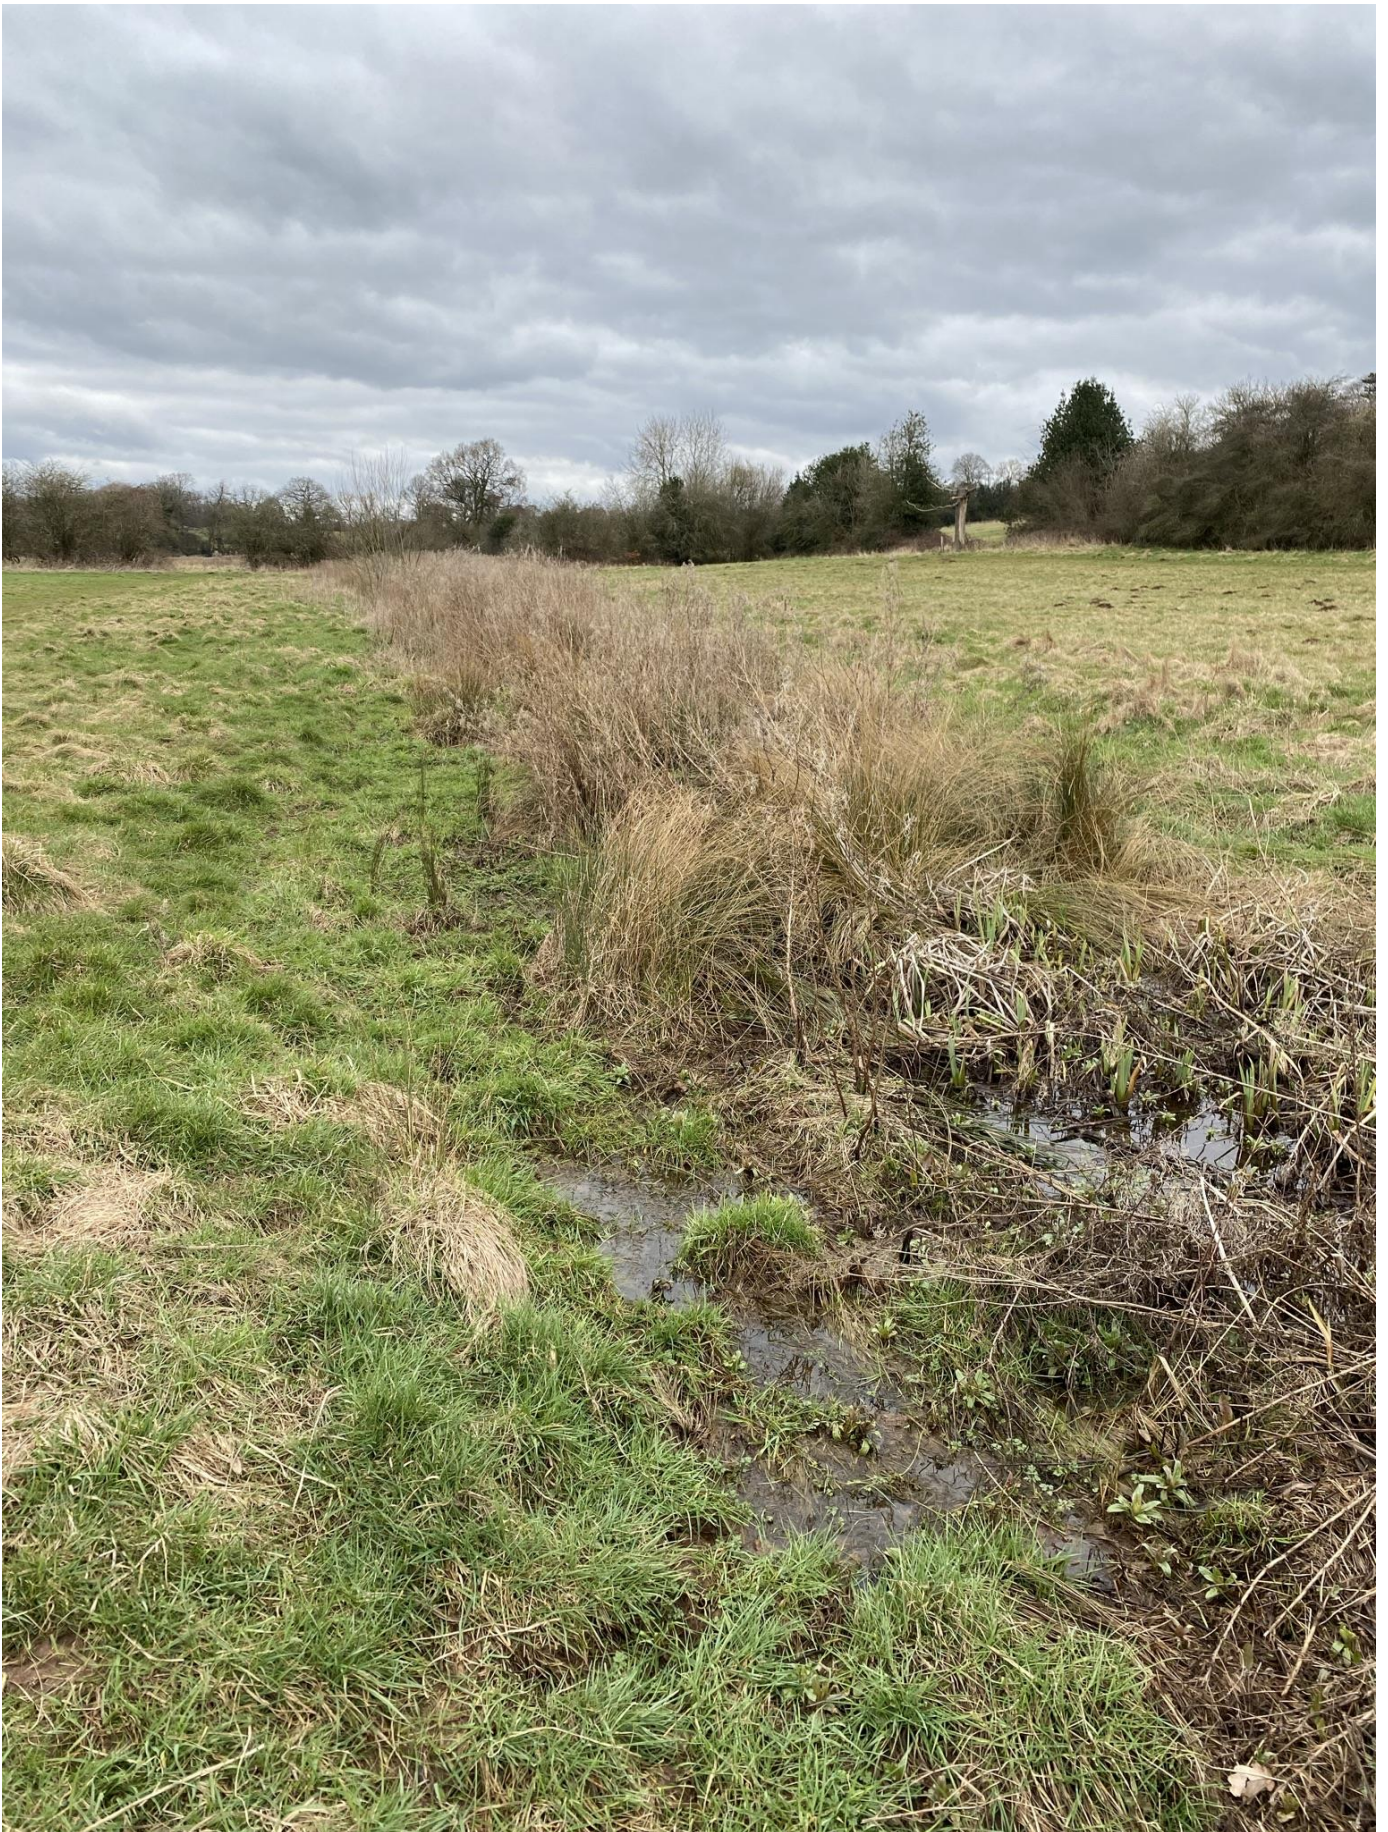
Figure 2.5 Palaeo channel along valley bottom of southern field looking upstream

The palaeo channel is still well defined in the left bank floodplain, with the southern area of the channel being fed by a ditch originating from the left-hand valley edge, see Figure 2.5 (facing downstream). This section of the channel is fairly confined within the valley bottom, offering limited opportunity for wider floodplain works alongside reconnection. The wetland area within the northern section of the study area is possibly a former pond with presence of several wetland species including soft rush, common sedge, common reed yellow flag, creeping buttercup and young willow (Figure 2.6). Several flow routes are evident north of this wetland area (Figure 2.7) that could be targeted as part of this stage zero approach for reconnecting this floodplain area and bypassing the weir. Flows are likely to spread across this wetland area to the north of the site once reconnection takes place. Flows along the southern section of palaeo channel currently flow back into the main channel close to the footpath, a section of ground could be lowered to spread flow across a wider area when it reconnects to the existing channel to reduce the risk of frequent flooding across the footpath (Figure 2.9). The watercourse splits locally and displays active medium gravel bed and bar features (Figure 2.9) immediately downstream before it reaches the next weir and pond structure.

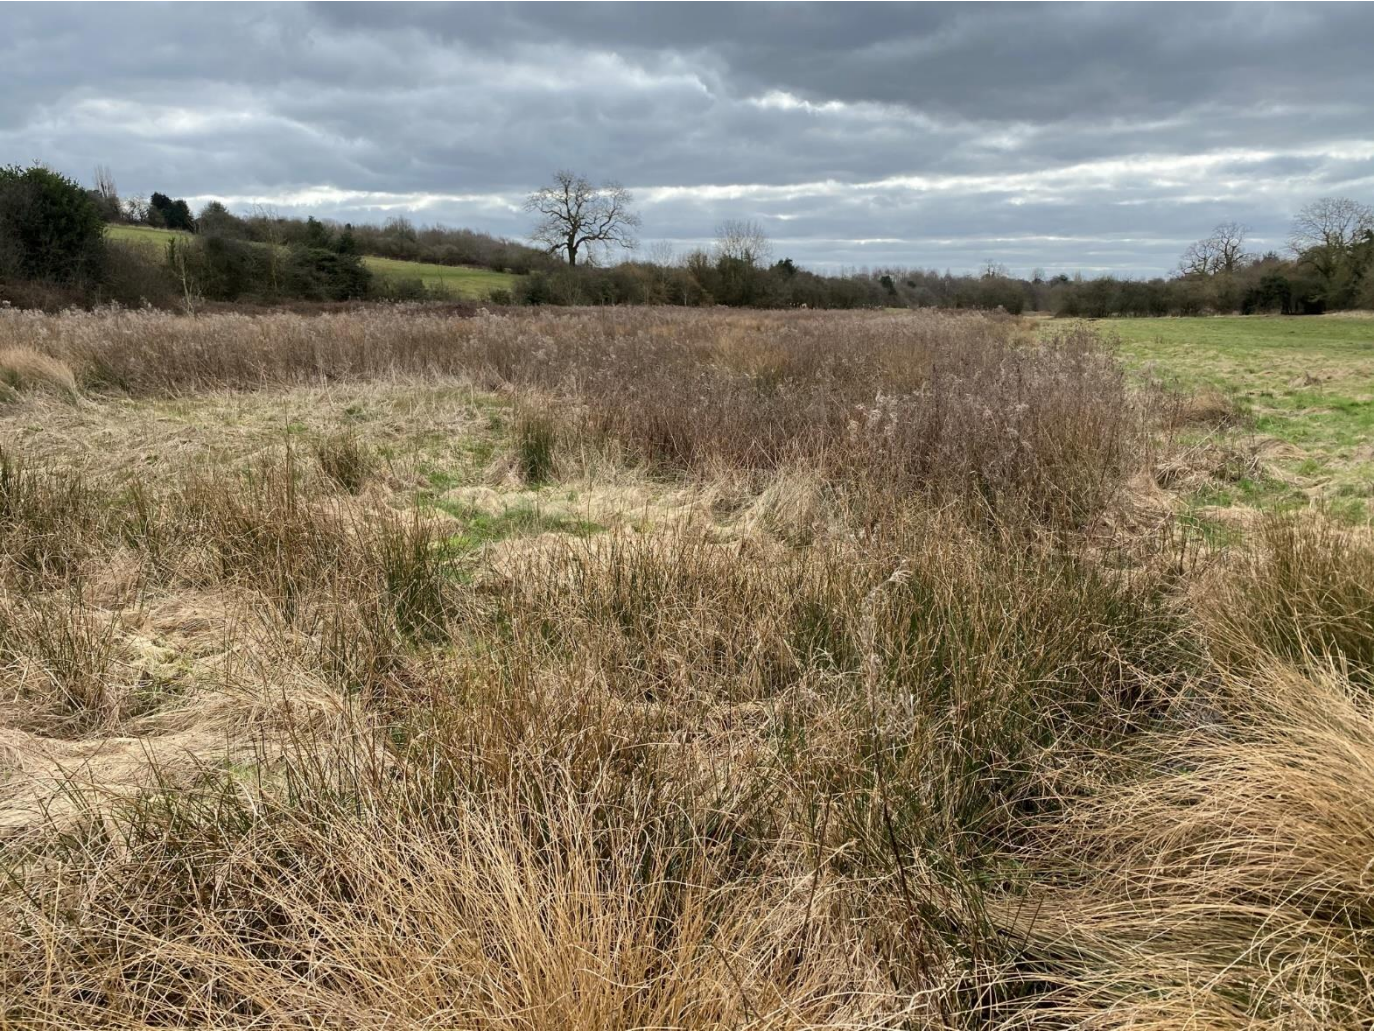
Figure 2.6 Existing wetland area diversity

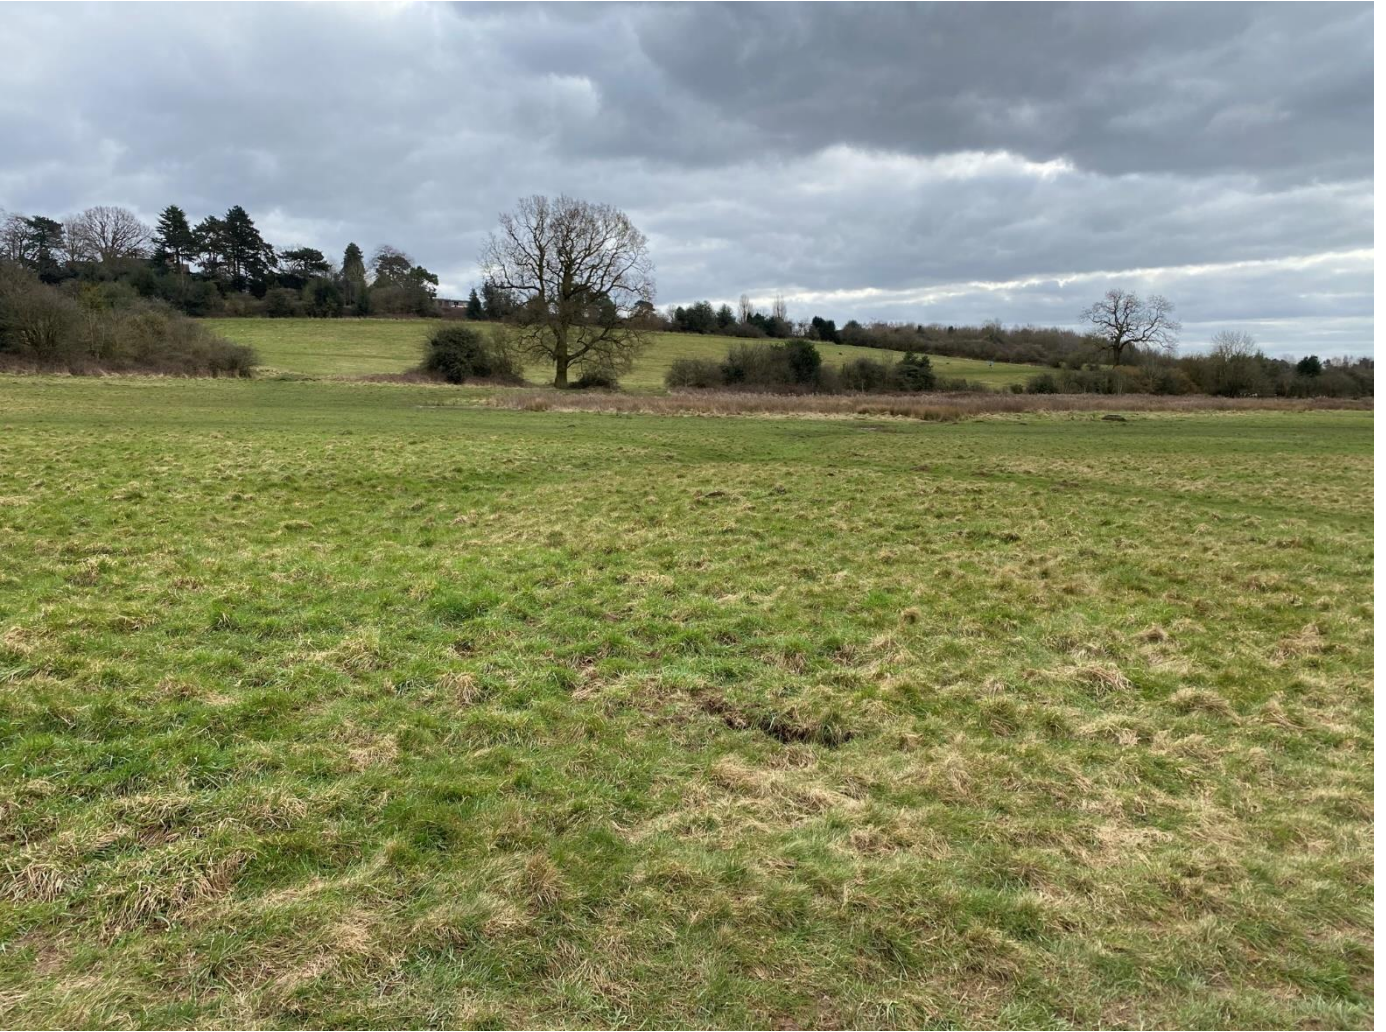
Figure 2.7 View of palaeo channel to be reconnected at upstream end of reach towards existing wetland

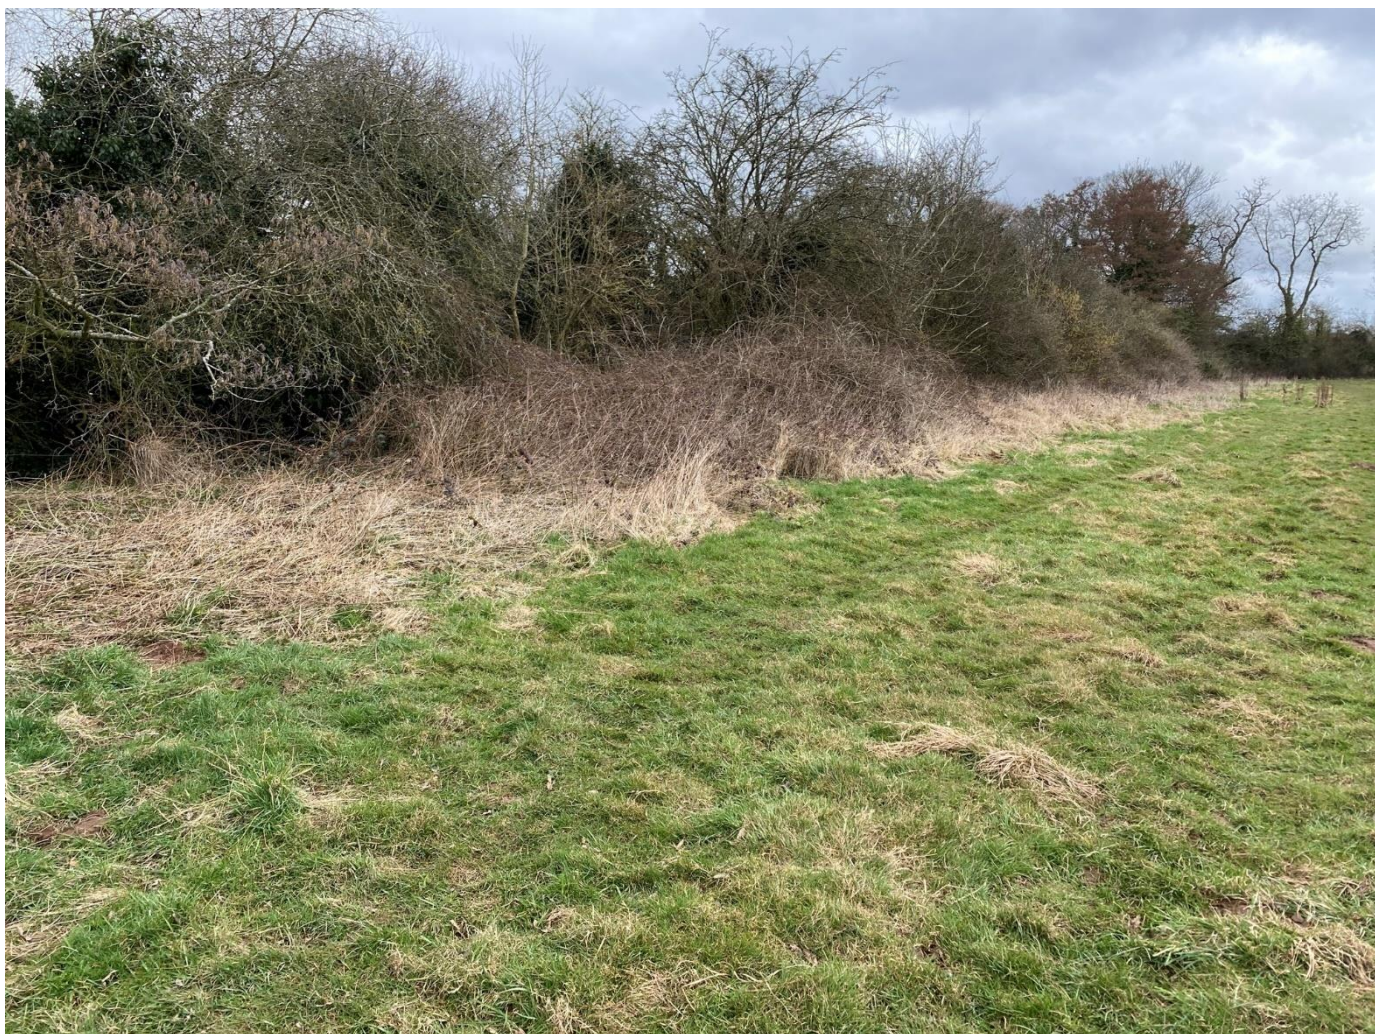
Figure 2.8 View of upstream left bank reconnection area where scrub and trees will need to be removed

The current watercourse is reasonably well connected to the floodplain along the reach where the upstream reconnection to the palaeo channel is being considered (Figure 2.8), with channel depths generally not exceeding 0.5m. It becomes deeper in places where it flows north to south along the valley edge, with several crossing points and pipes impacting the flow and sediment regime. The weir itself being bypassed as part of this scheme is formed of a culvert underneath a footbridge (Figure 2.10) which presents a complete obstacle to fish passage. The head difference across it is approximately 0.75-1.0m and is in a poor overall state with some flow bypassing the culvert and around the structure, and some scour where flow now exits the culvert.

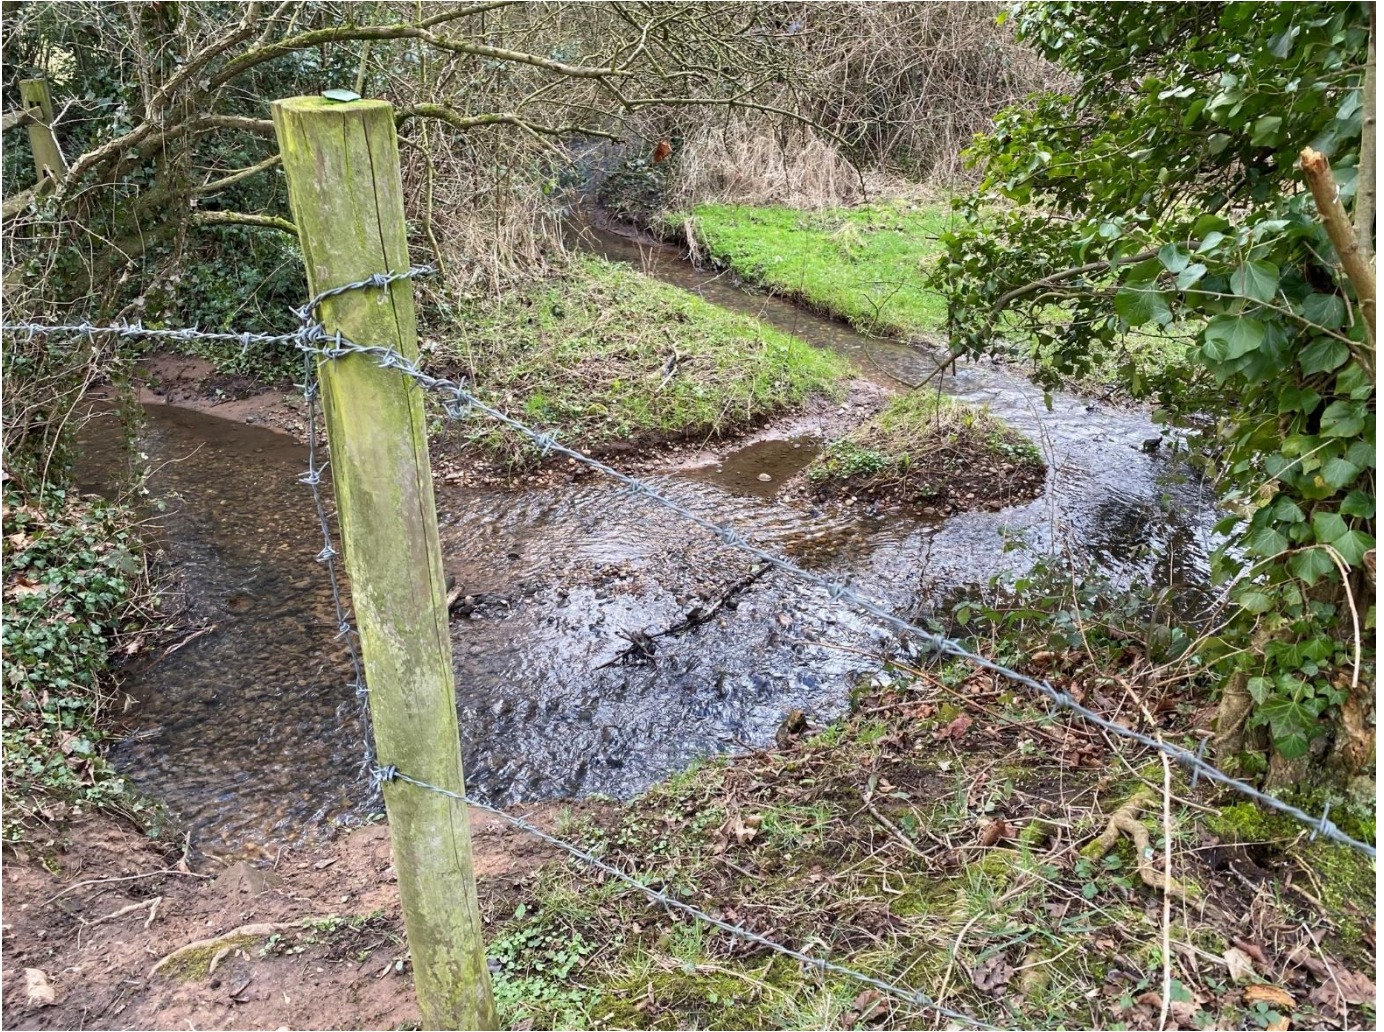
Figure 2.9 View of downstream reconnection area showing gravel bed and bar features

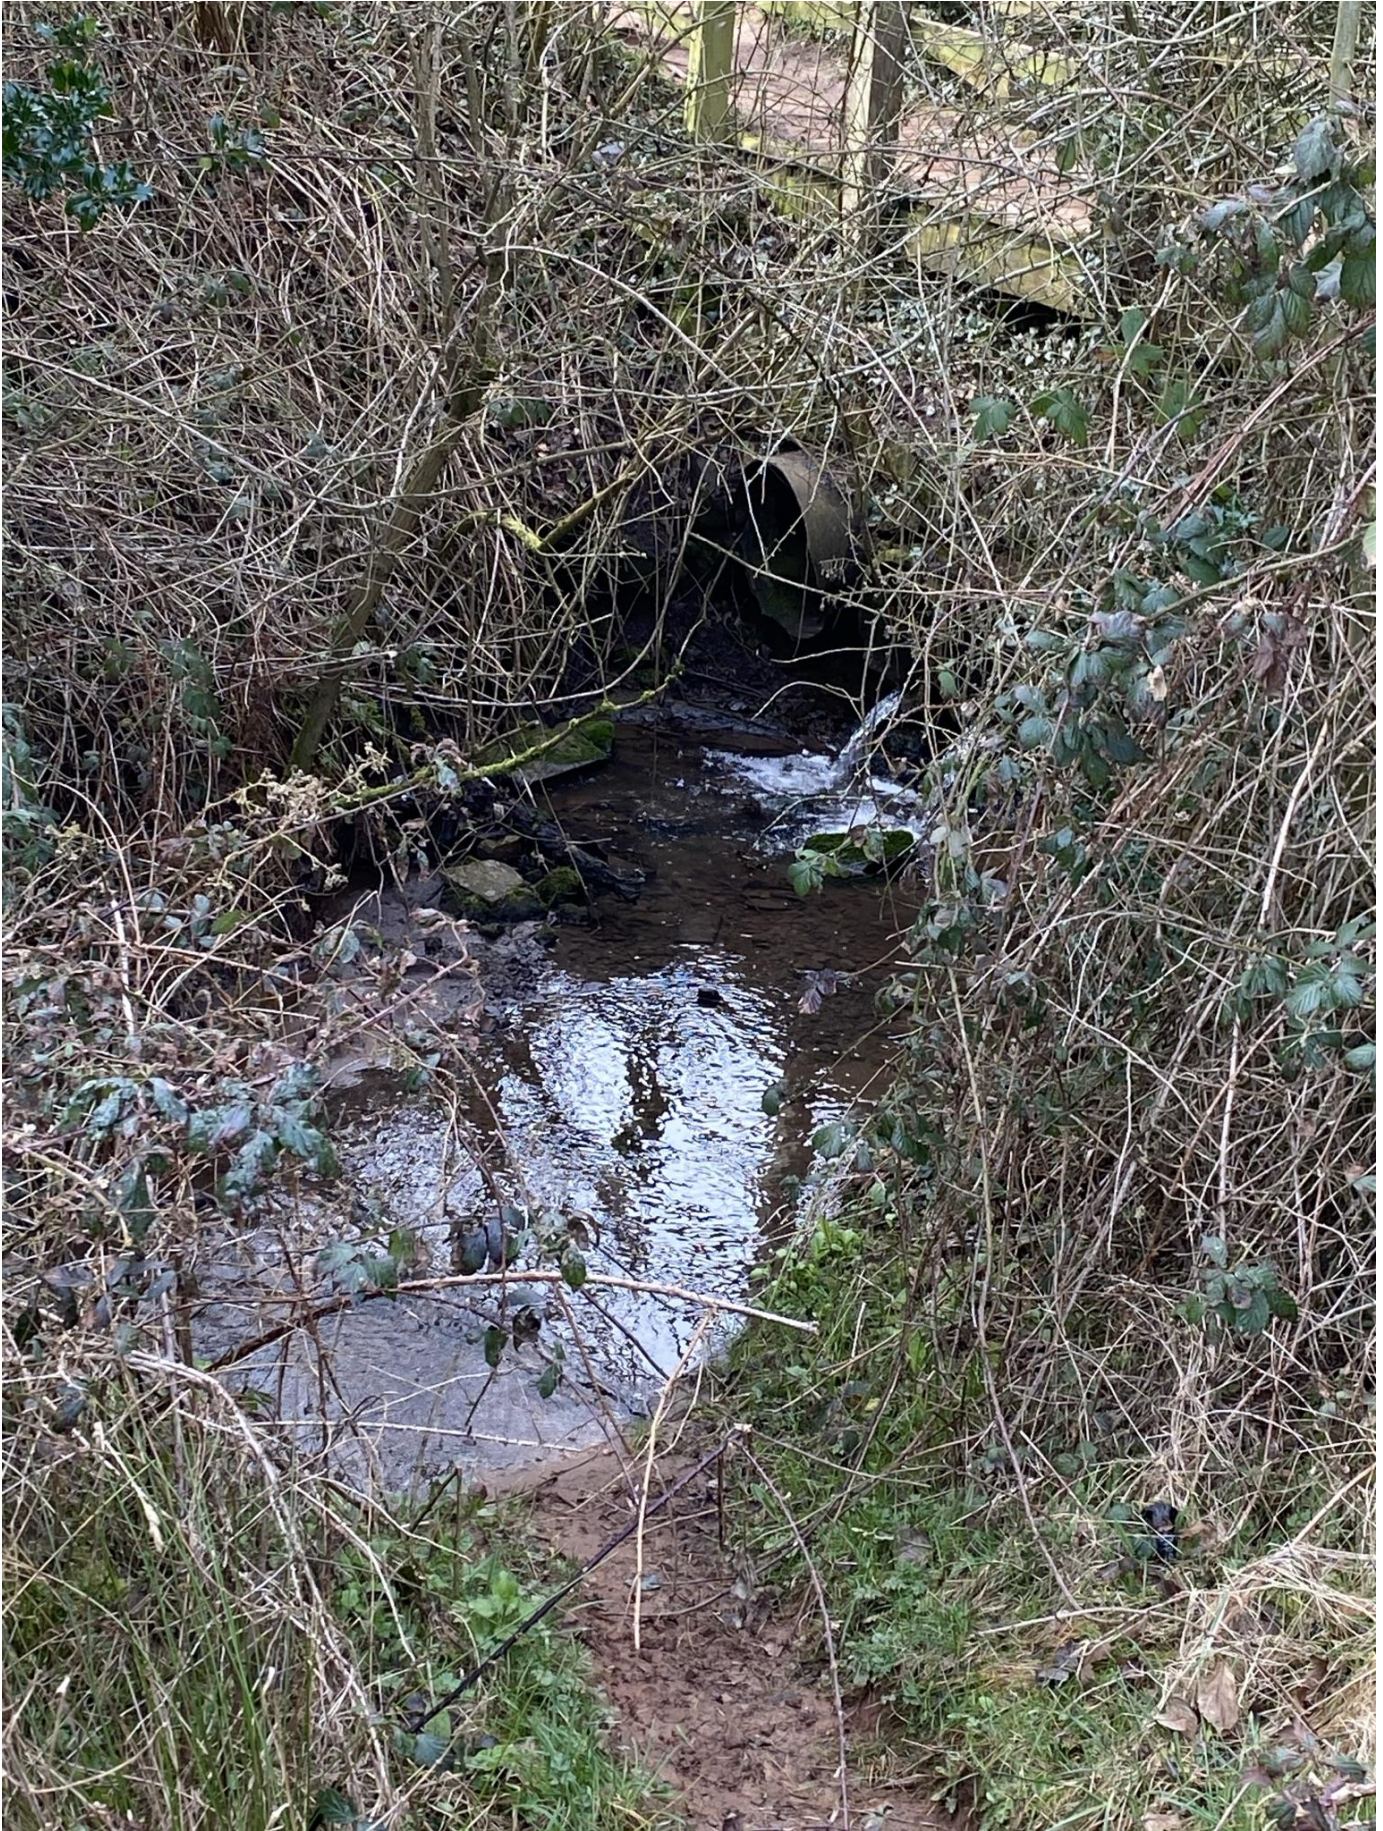
Figure 2.10 View of existing culvert and weir

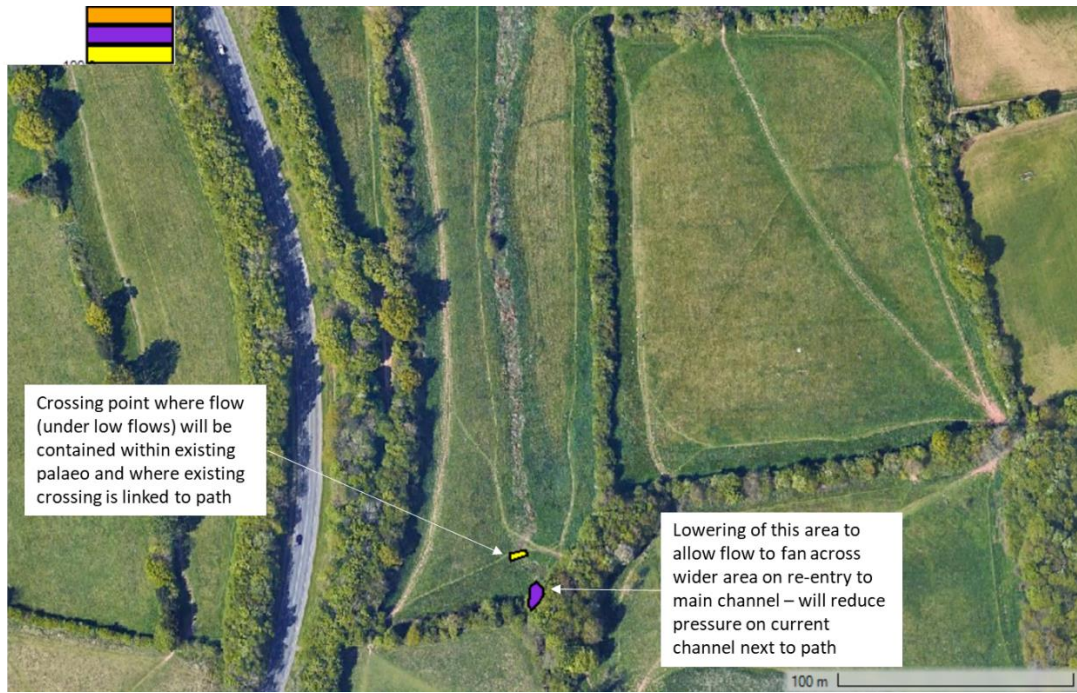
Channel blocking
Local lowering
Crossing points

Figure 3.2 Identified options at downstream end of study area along the North Brook

Initial review and identification of options following the field audit and initial hydraulic modelling (see section 3.2), has been undertaken, with options proposed that work with the principles of a 'stage zero' type approach to reconnecting the palaeo channel and providing fish passage around the weir structure. These options are shown below, including how these relate to the topography, in Figures 3.1 and 3.2 alongside the benefits linked to these options, and example features provided in Figures 3.3 to 3.7.

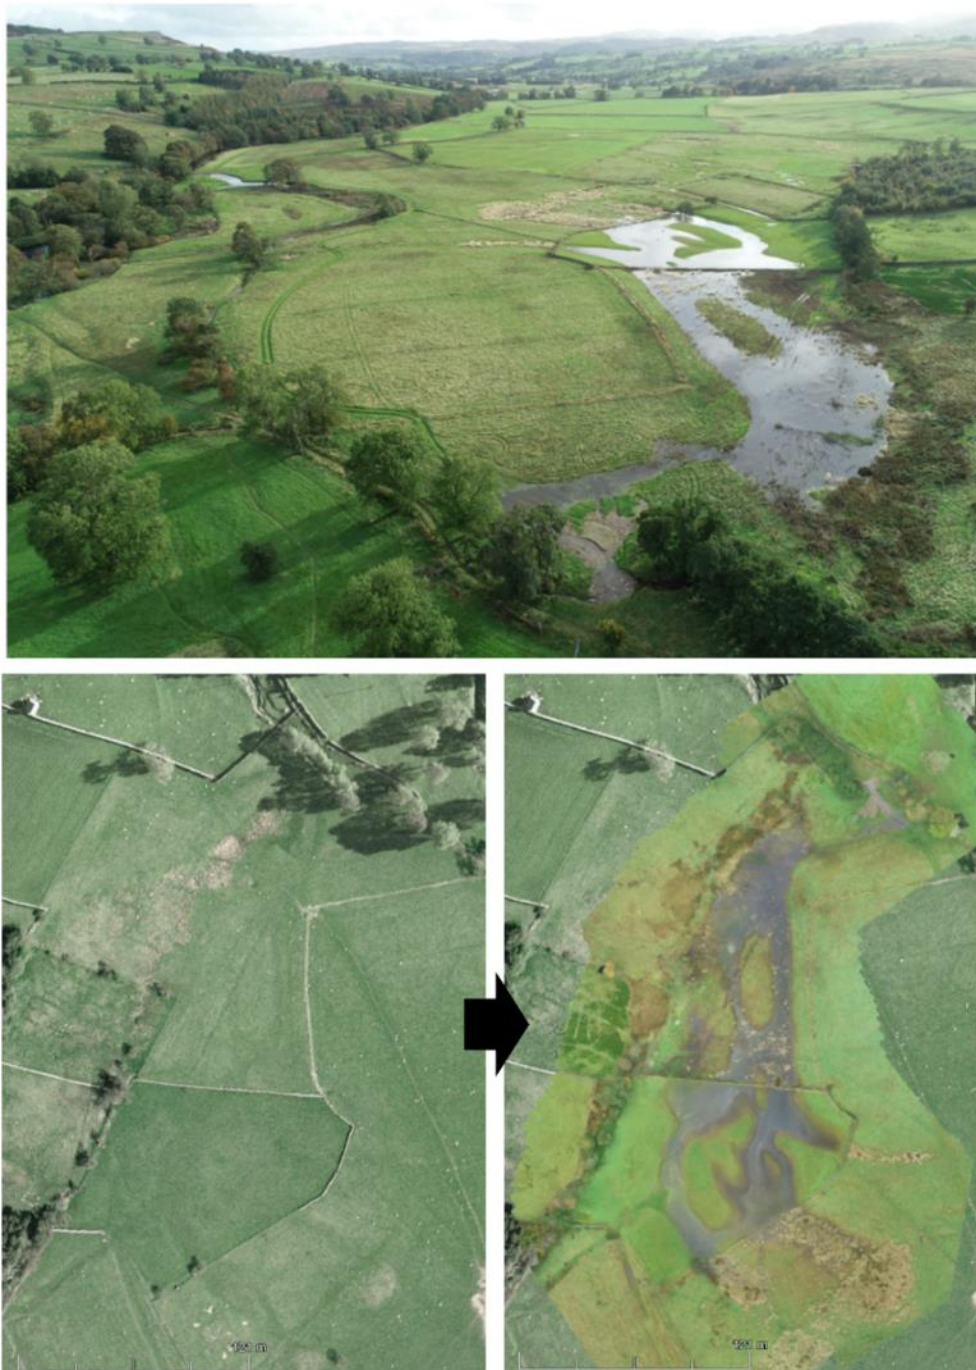
Figure 3.3 Example large wetland area created by through tributary blocking of Milkeld Sike on the Lowther Estate. Indicative of possible winter / rainstorm wetting of the North Brook site.

To achieve reconnection of the palaeo channel through the 'stage zero' type approach to providing fish passage at the site, channel blocking of the existing watercourse is proposed to divert flow into the palaeo channel network (alongside some local ground lowering). This will encourage the development and improvement of wetland through the rewetting of valley bottom and marginal areas through channel and ditch blocking. Example areas where this principle has been applied are shown in Figures 3.3 and 3.4.

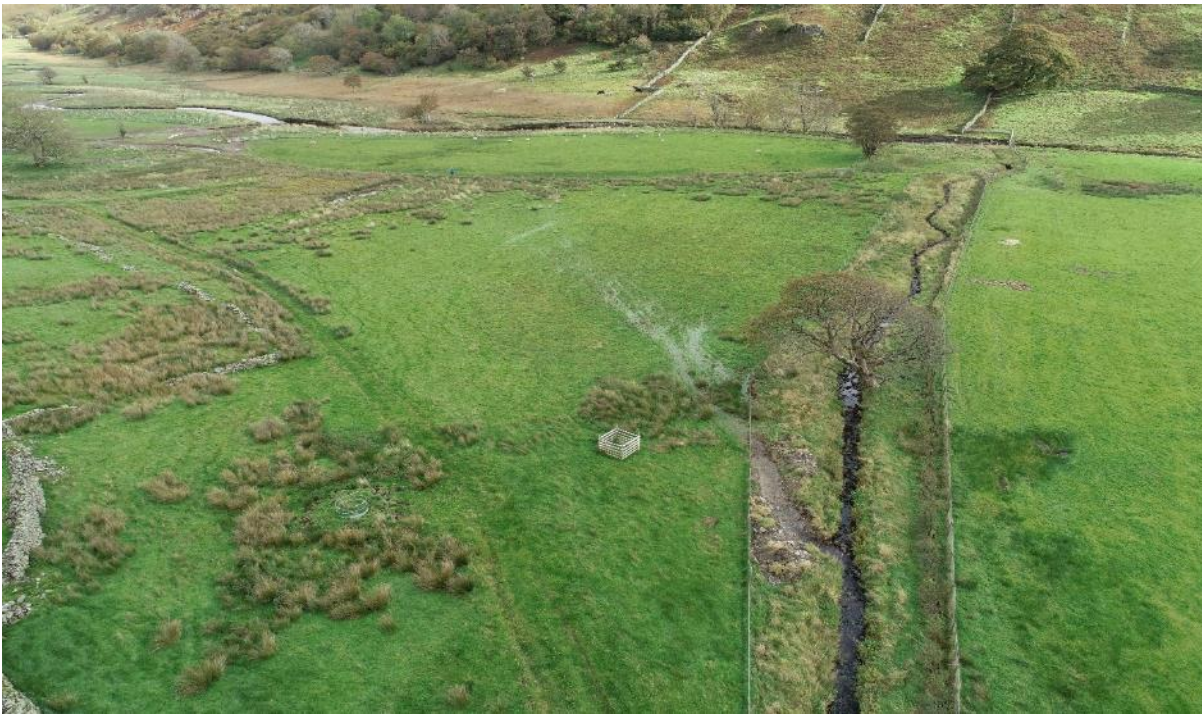
Figure 3.4 Diffuse valley side flow network created by drain blocking in the Swindale Valley. Indicative of possible high summer wetting of the North Brook site.

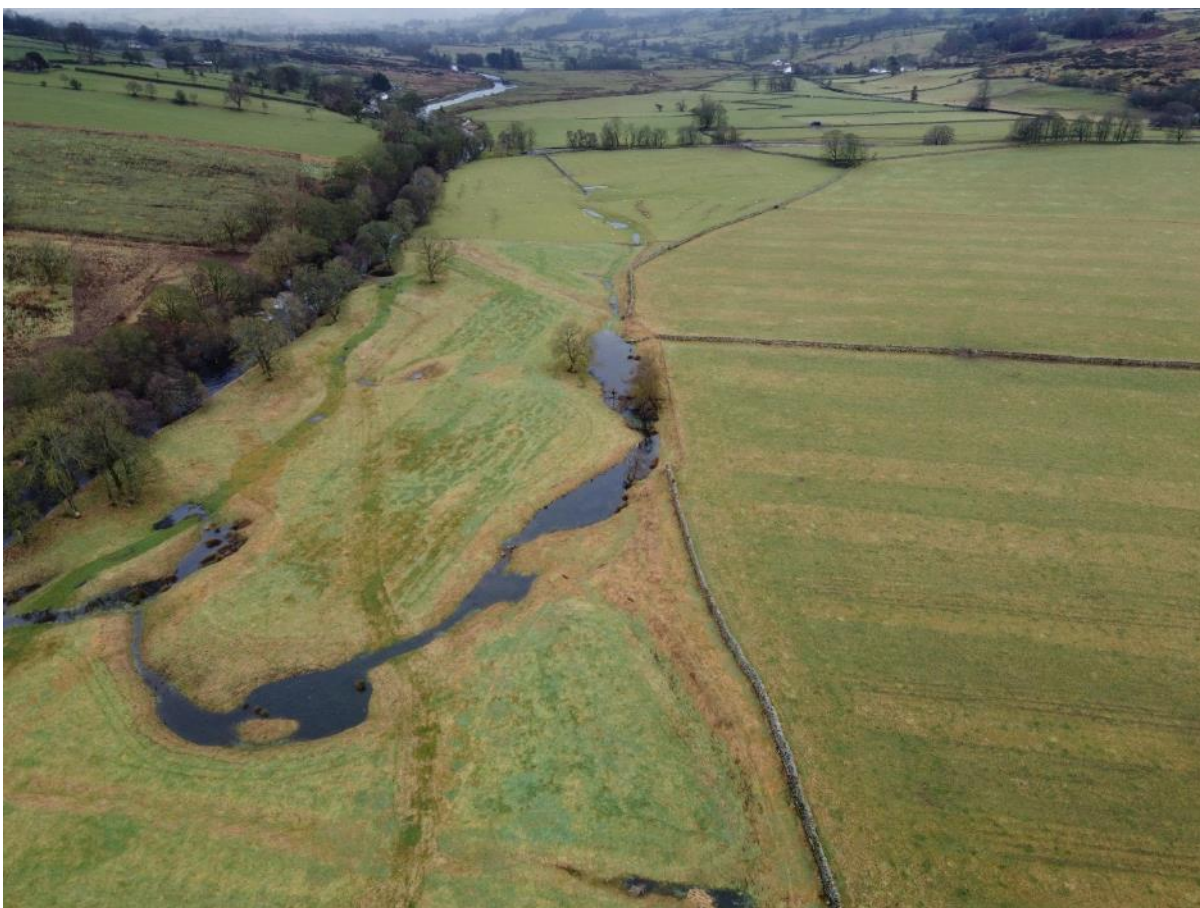
Figure 3.5 Palaeo-channel backwater reconnection on the River Lowther. Indicative of possible winter wetting of the North Brook site.

Figure 3.5 is an image on the River Lowther where a palaeo channel was reconnected to encourage wetting, similar to the principles of the palaeo channel reconnection proposed here. This was achieved through creating a breach within the embankment into the palaeo channel at the up and downstream ends to allow flow into it under elevated discharges and through introduction of gravel riffle features to raise normal water levels locally. Figure 3.6 shows the improved ecological diversity created following work undertaken to fully reconnect another palaeo-feature on the same river.

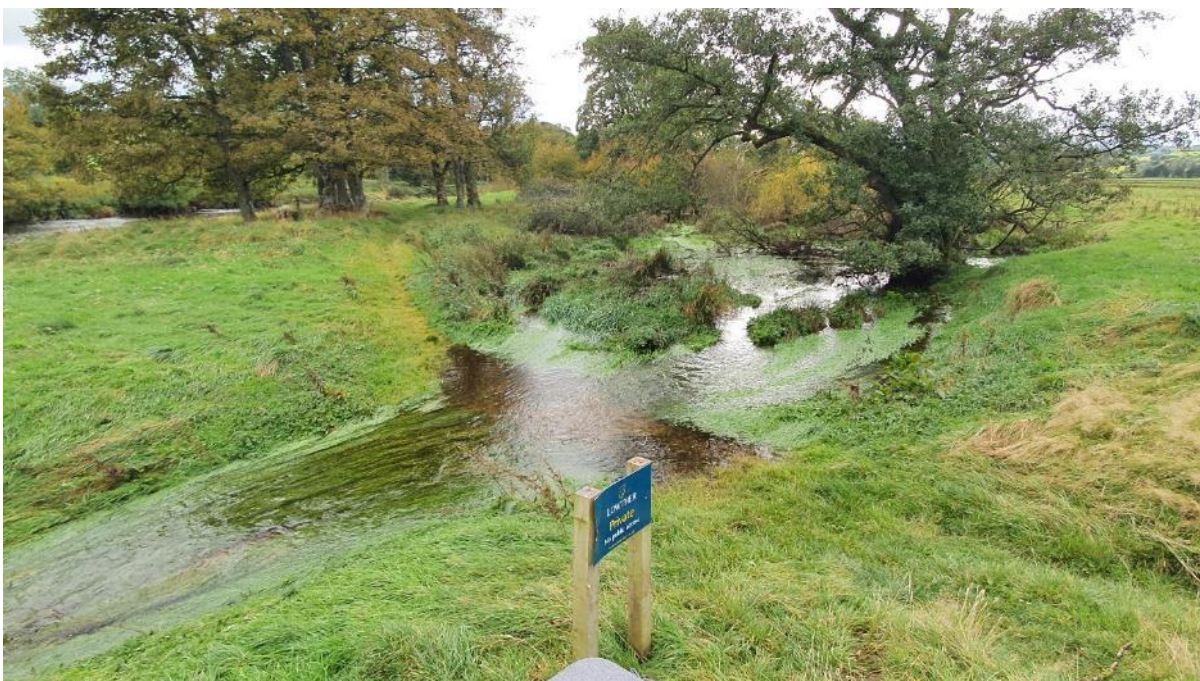
Figure 3.6 Example reconnected palaeo channel on the River Lowther. Indicative of possible winter wetting of the North Brook site.

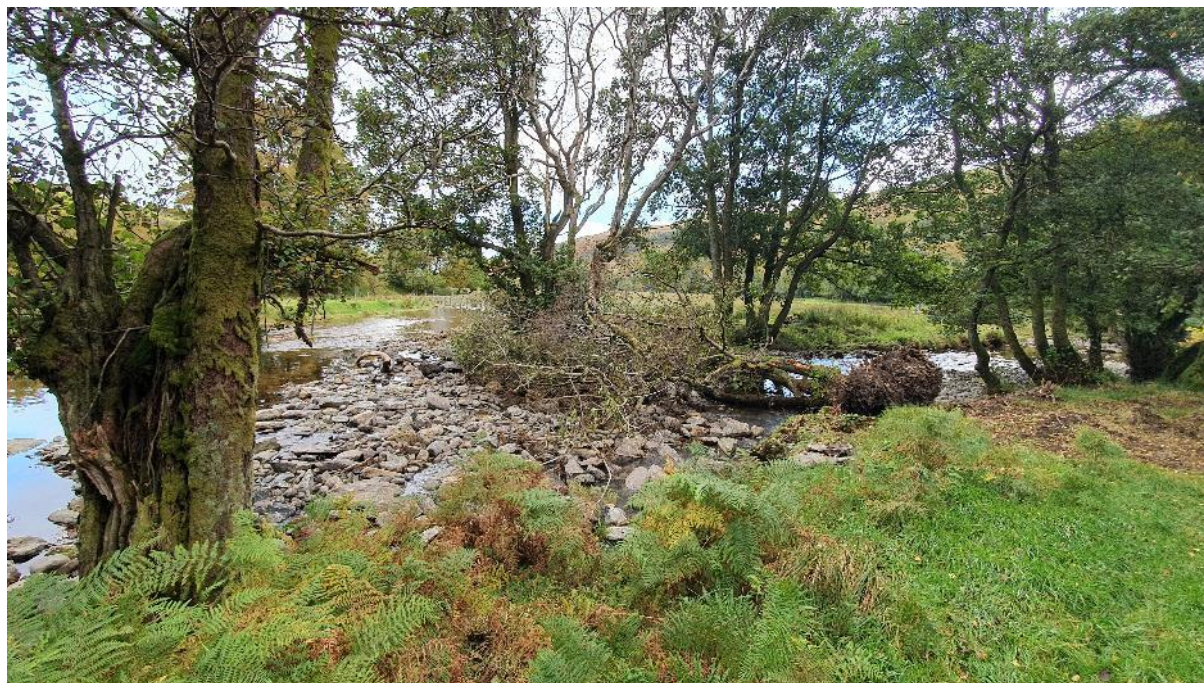
Figure 3.7 Alder pushed over in Swindale Beck to encourage channel avulsion processes.

Live and dead wood can enhance in-channel diversity and increase overbank flooding or can be used as dead wood features in the floodplain. Impact is greatest where wood is also coming down the system to help enhance accumulations. The roll of live wood and other marginal and aquatic vegetation in influencing channel and floodplain development in low to moderate energy rivers is little researched but vitally important and restoring wood reintroduces a missing natural influence on these systems (Figure 3.7).

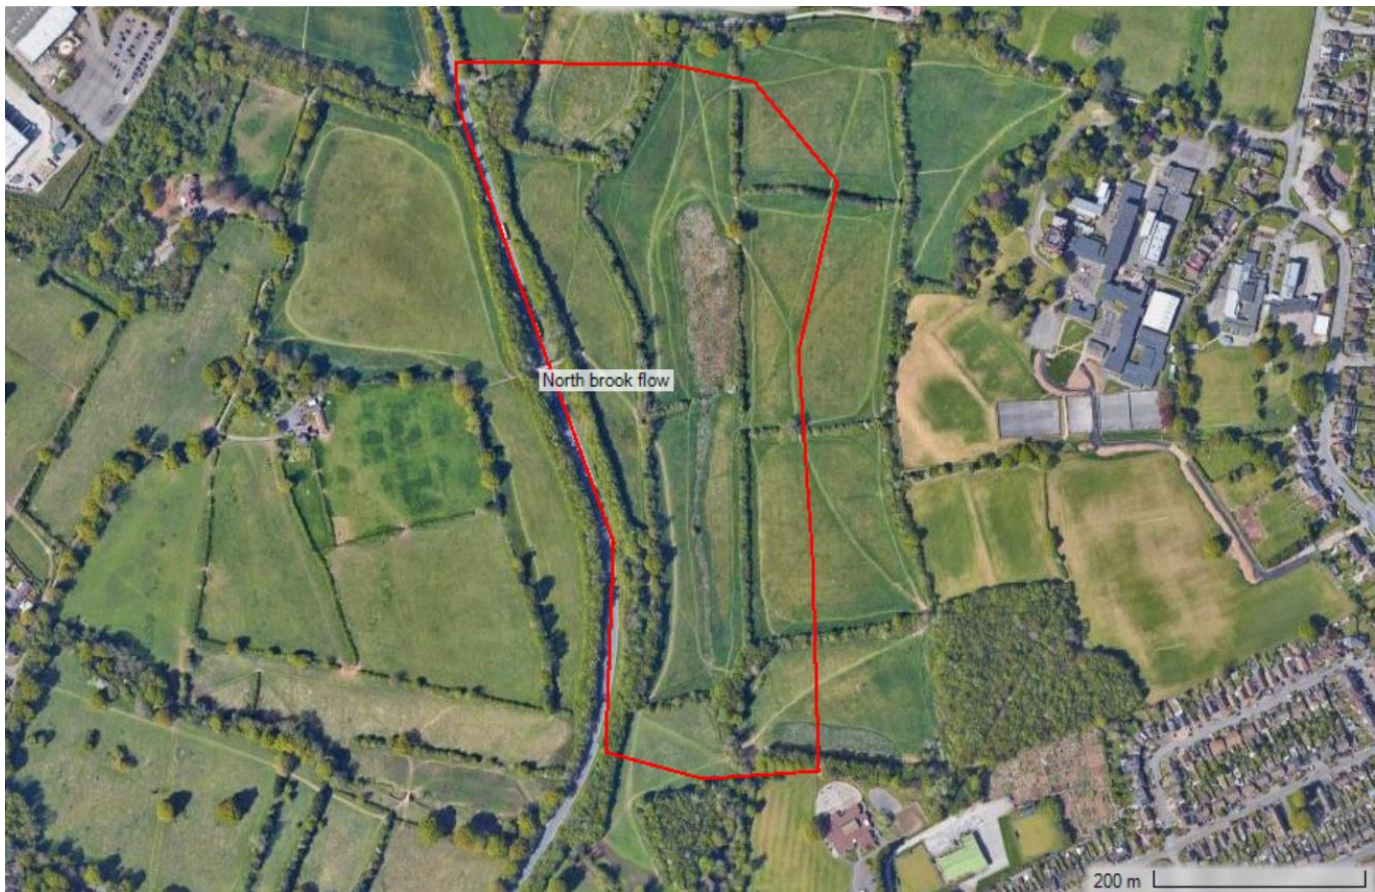
Figure 3.8 Model extent for North Brook study reach

The model has been built using a Digital Elevation Model (DEM) across the model domain that provides a ground elevation value for each 1 m grid cell. The model extent is shown in Figure 3.24 below.
