DYNAMIC
RIVERS

**North Brook Weir
Restoration Design
FINAL Report**

Warwickshire Wildlife Trust

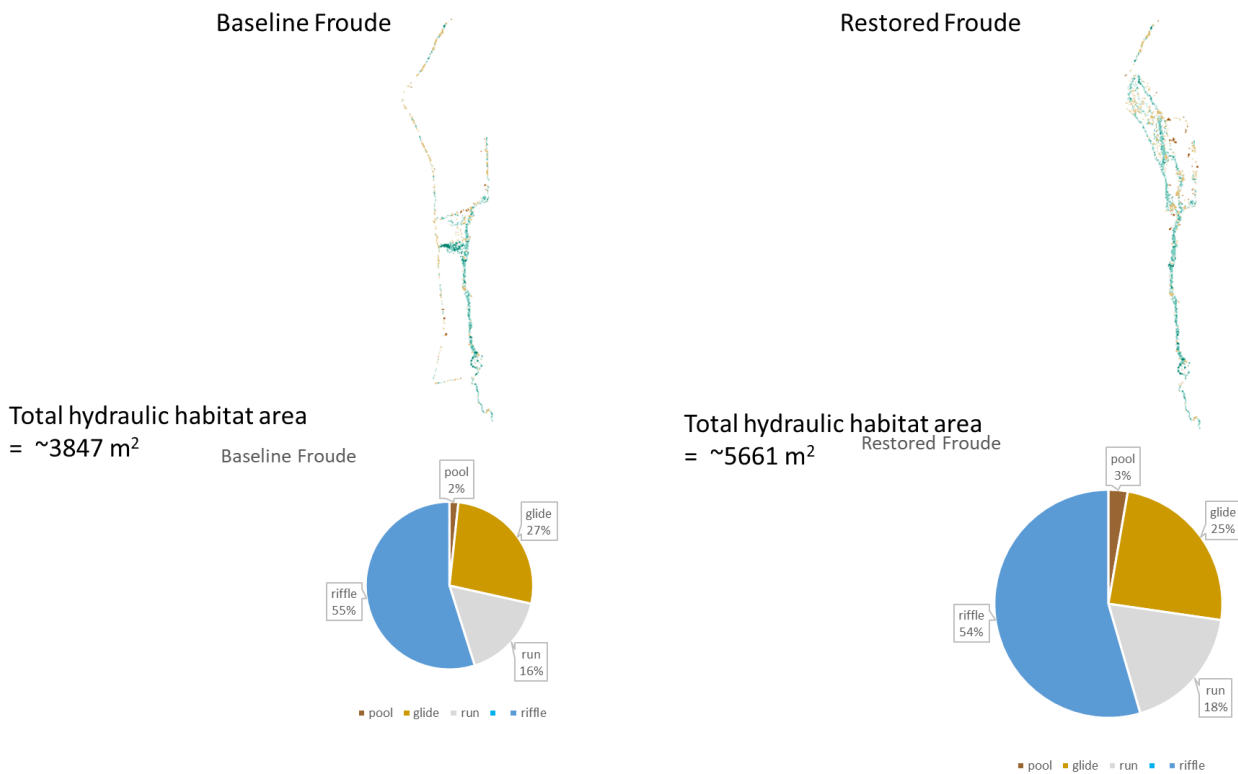
Figure 3.11 Strong summer flow hydraulic habitat / biotope change compared to baseline for entire study reach and associated overall habitat area and diversity change (pie charts scaled to area).

Figure 3.11 shows the hydraulic habitat change, compared to baseline, under strong summer flow conditions as a result of the preferred scheme design.

There is a change in both hydraulic habitat diversity and, significantly, in overall hydraulic habitat area as a result of the preferred scheme for a strong summer flow. There is increase in higher energy biotopes overall as a result of the impact of the weir on current flows in the main channel. Otherwise, there is a strong diversity in overall hydraulic habitat suggesting a complex of wetland habitat will be created as a result of the scheme. There is also a very significant increase in overall hydraulic habitat area when compared to baseline under the same flow conditions, increasing from ~3850m² to 5660m². This is a result of the overall improved connectivity to the floodplain and associated wider wetted area and is a very significant gain as a result of the proposed scheme.

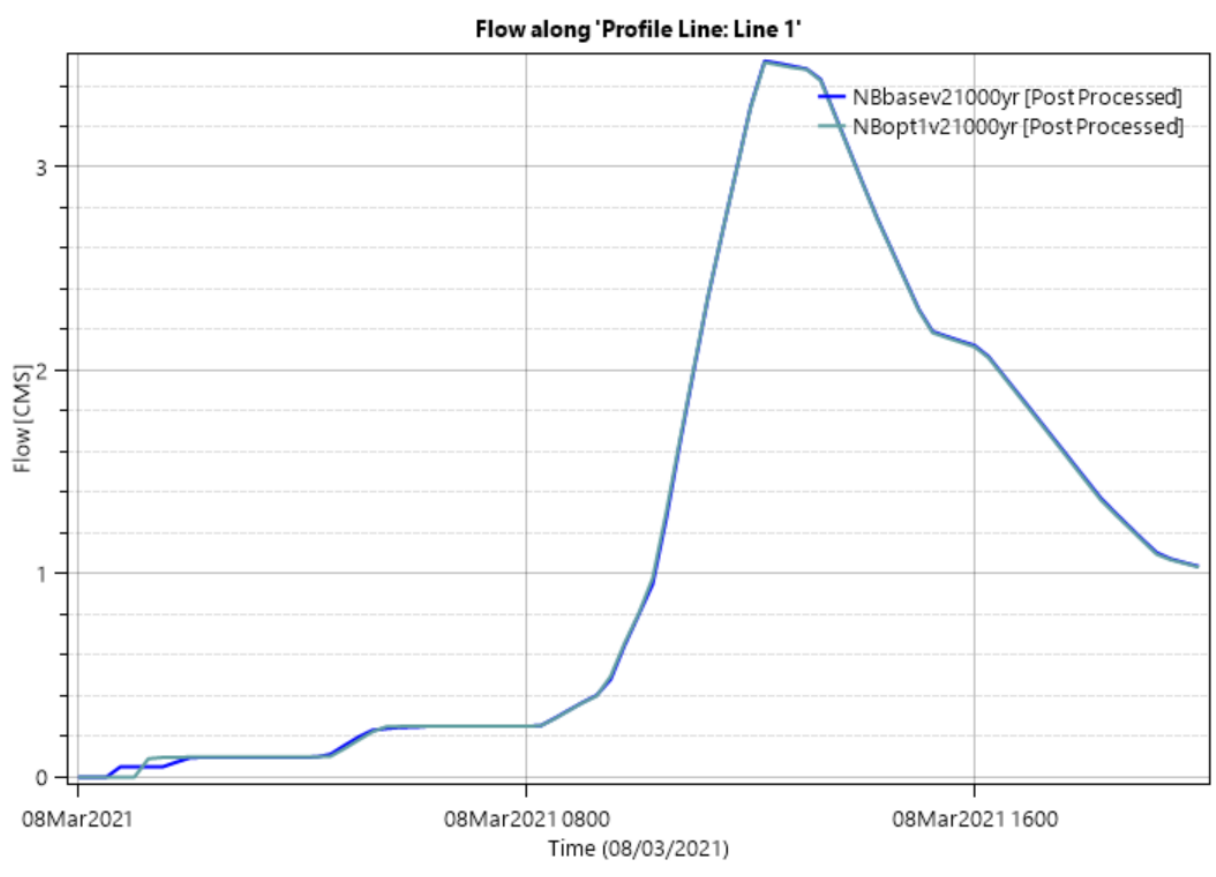
Figure 3.15 Downstream flood hydrograph change across all modelled flows.

Downstream, the impact of the proposed works across all the modelled extreme return period flows is negligible with no significant changes in the flows monitored at the downstream extent of the model when compared to baseline. This is unsurprising given that flood flows do spill out into this area under modelled baseline conditions anyway. This is demonstrated in Figure 3.15 below. This concludes that there is no increase in downstream flood risk as a result of the proposed works.
